Inspection report for the property at

Sample Address 1

This report is prepared exclusively for **Sample Report**
On: **2021-11-04**

Frazier Inspections LLC
330.903.3334

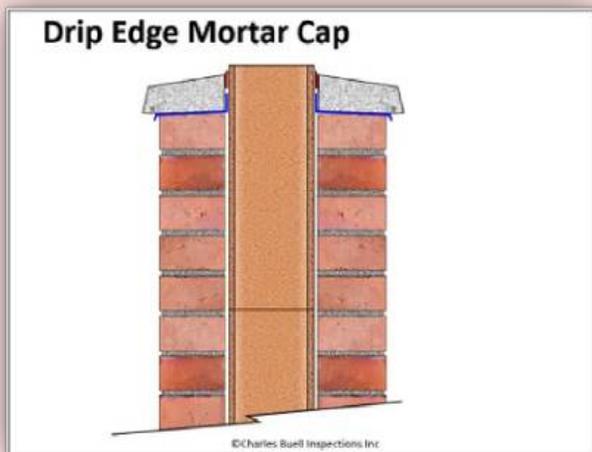
(RCG-4) Defect Requiring Qualified Trade Contractor: Failing mortar was noted at the masonry chimney above the roof line. This condition risks increased water entry and penetration into the masonry chimney which can lead to water damage, loose bricks and eventually a failing structure. Hire a licensed masonry contractor to further evaluate and repair the masonry chimney as recommended.

(RCG-5) Defect Requiring Qualified Trade Contractor: The concrete chimney cap is in poor condition and requires repair to prevent water from entering and damaging the chimney. Hire a mason to further evaluate and repair the masonry chimney cap.

RCG-4 Roof, Chimney and Gutters: Failing mortar was noted at the masonry chimney above the roof line. This condition risks increased water entry and penetration into the masonry chimney which can lead to water damage, loose bricks and eventually a failing structure. Hire a licensed masonry contractor to further evaluate and repair the masonry chimney as recommended.

RCG-5 Roof, Chimney and Gutters: The concrete chimney cap is in poor condition and requires repair to prevent water from entering and damaging the chimney. Hire a mason to further evaluate and repair the masonry chimney cap.

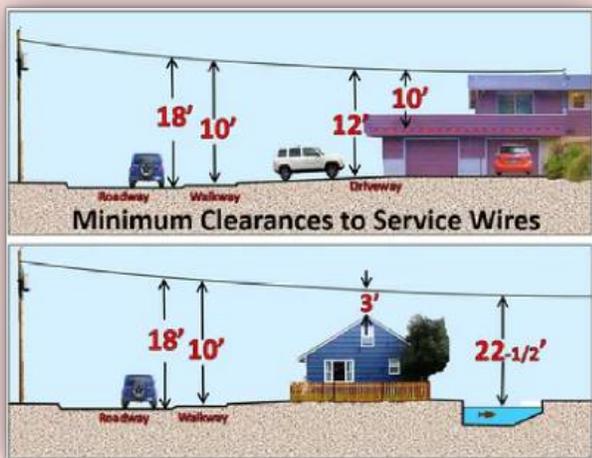
(ES1-2) Defect Requiring Qualified Trade Contractor: Some of the wires in the electric drop appear to have damaged insulation. This is a potential safety hazard that can lead to arcing and even fires. I recommend additional inspection of the electric service conductors by the utility. Repair as needed to ensure reliable performance.

(ES1-3) Defect Requiring Qualified Trade Contractor: Trees and vegetation are impacting the overhead electric service drop. This can fray through insulation and cause damage to the conductors and even arcing and fires. I recommend additional inspection of this drop by the utility. Remove trees, limbs and vegetation as needed and repair conductors if needed.

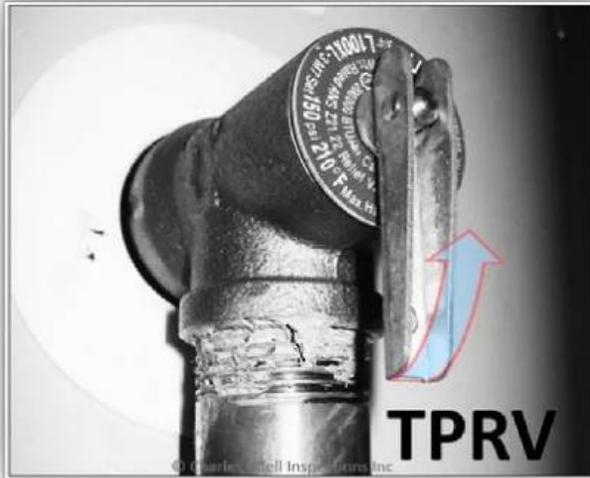
The arrow shows how a TPRV can be tested

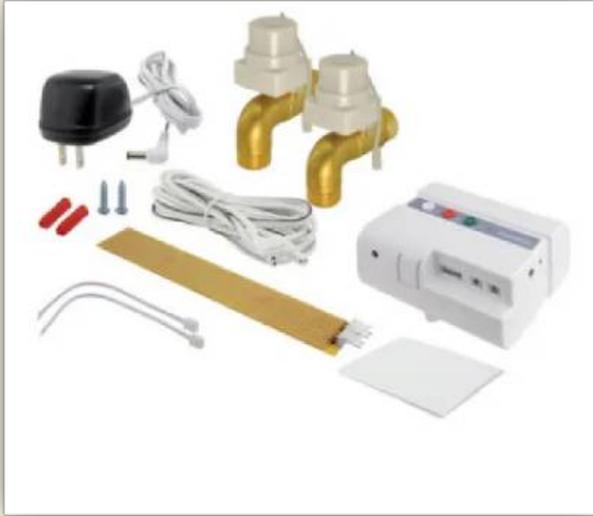
**(LF-1) Improve:** A moisture alarm with water shut-off features is recommended under the washing machine to protect against accidental leaks in the supply hoses. Pans can be effective

when there is a drain, but even these will not protect against a burst supply connector. A moisture alarm with automatic shut-off will. Watts is a brand I have seen installed: [Link](#).

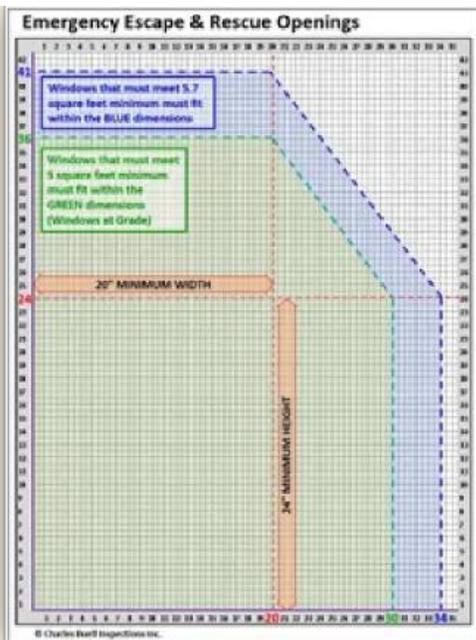
**(SB-2) Repair:** The basement bedroom has no provision for escape and rescue. This is typically provided through an approved [escape and rescue opening](#): a window or door and the window must meet some basic minimum size requirements that can have variation and exceptions but are basically: no more than 44-inches off the ground and with at least 5.7 sq/ft opening and at least 20-inches wide.
